Finding old Tillimby: a desktop review from archival photographs, historical satellite imagery and other publicly available sources.

Brian Walsh, PhD, MPHA
29 July 2018

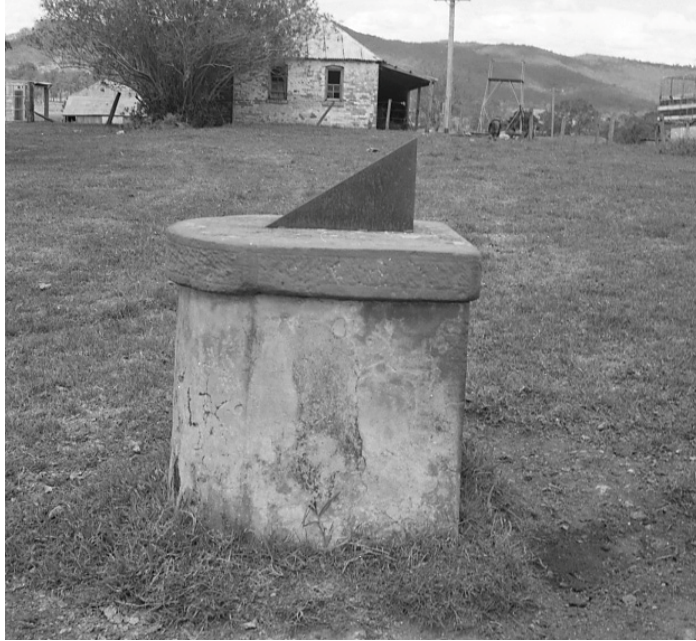
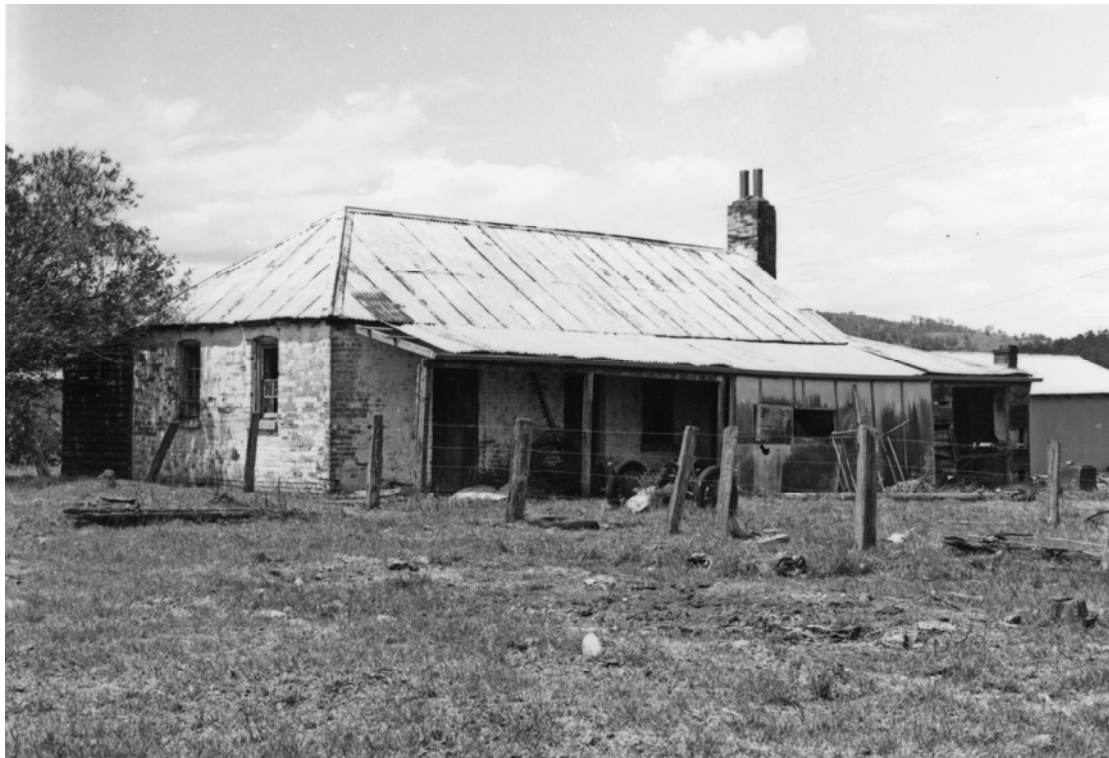
Tillimby's sundial survives today as a relic of a colonial-era garden, presumably near the main residence. Both garden and residence are long gone. The sundial therefore provides a reliable point of reference for the interpretation of other evidence. Athel D'Ombra's photos (c1960s?) show the sundial and the "servants' quarters".

Above and below: sundial and "servants' quarters" at Tillimby, c1960s (Athel D'Ombra, Newcastle University Cultural Collections).

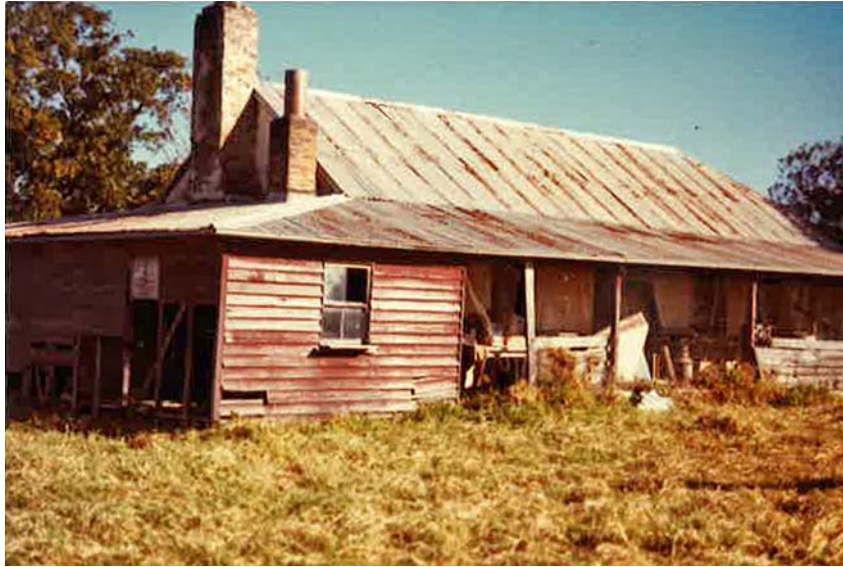
On the next page there is a colour photograph of the rear of the servants' quarters. Note the cluster of chimneys on the eastern end, and the timber infill on the verandah. These are vital clues to identifying the building in other photos.

The servants' quarters photographed from the opposite side to D'Ombra's. (Paterson Historical Society, courtesy of Greg Priestley).

Using magnification, a close examination of the smaller building in the middle foreground shows the timber infill on this side matches the colour photo of the servants' quarters shown earlier. The chimney cluster on the end of the building is also evident under high magnification. All the features of the building, including its distinctive asymmetrical ends, match the previous photographic evidence of the Tillimby servants' quarters.

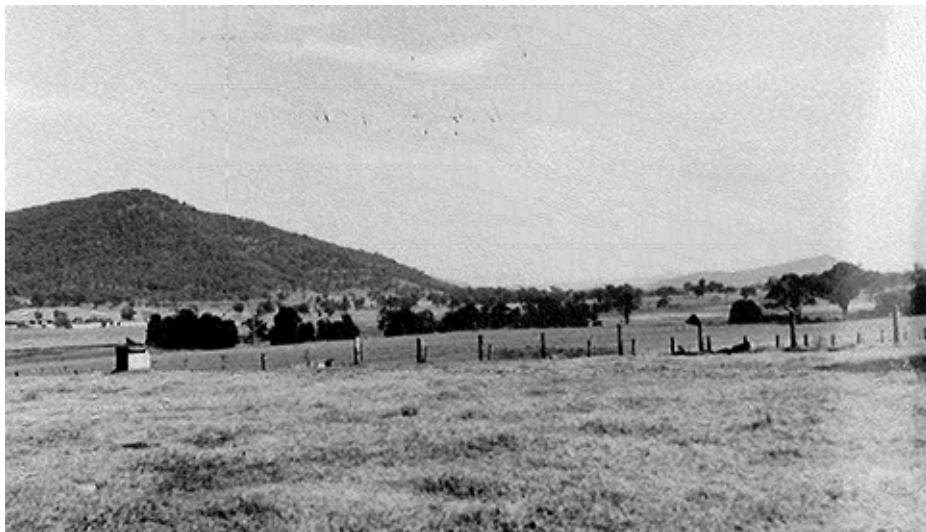
Tillimby's sundial, looking north west. (Dungog Heritage Study 1987).

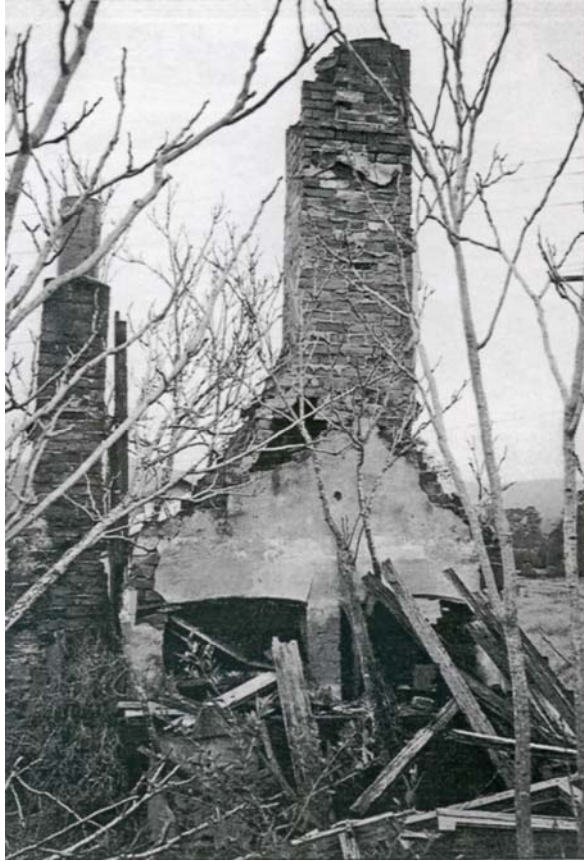
The next available evidence comes from photos taken in 1998 by the late Bill Anderson and used in Dulcie Hartley's book "John Herring Boughton of Tillimby". The first photo shows two of the chimneys on the eastern end of the servants' quarters. The second shows that the sundial has now been fenced off to protect it from livestock.

Above: the chimneys of the servants' quarters in 1998. Below: the sundial (Bill Anderson).

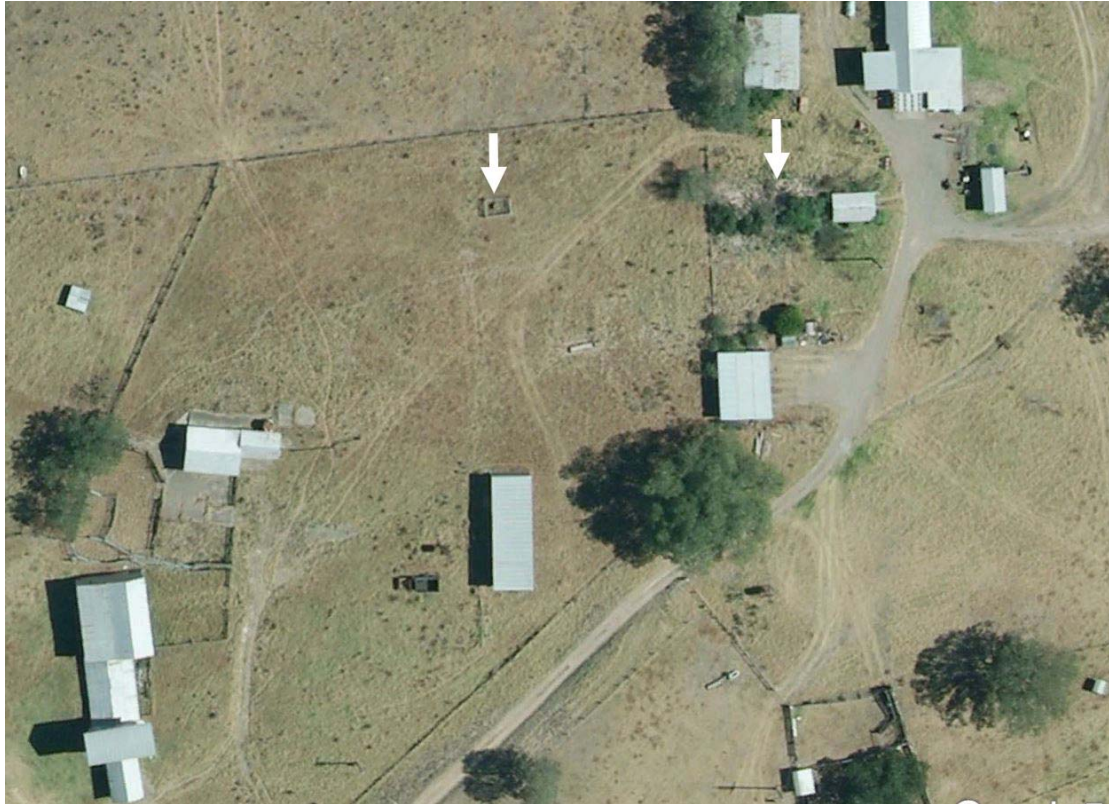
The 2010 Google Earth satellite image showing Tillimby (arrows added). The sundial is indicated by the arrow in mid image, the rubble footprint of the servants' quarters by the right arrow.

The detail in the above image, including a small shed immediately to the east of the servants' quarters and an old power/telegraph pole nearby, crosschecks accurately with the detail in the c1960s D'Ombra photos before the building was demolished.

For the record the GPS location of the sundial is 32° 34.684'S; 151° 36.713'E. The centre of the Servants' quarters is 32° 34.686'S; 151° 36.740'E.

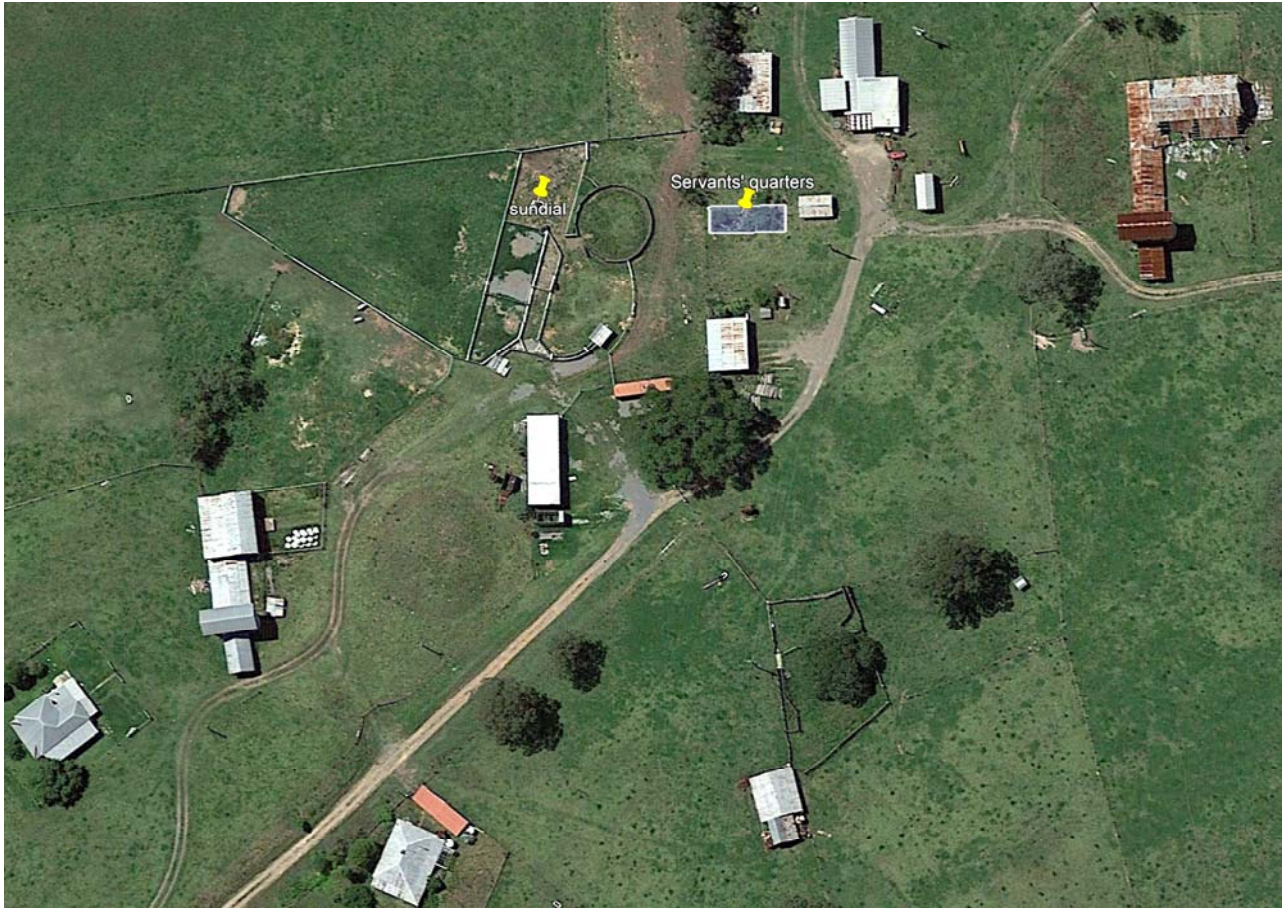
The satellite imagery shows that construction of stockyards near the sundial began in 2013. By 2014 the yards surrounded the sundial which was now protected by a new fence around it, within the yards.

Satellite image from 2016 showing the sundial within a set of stockyards. (Google Earth).

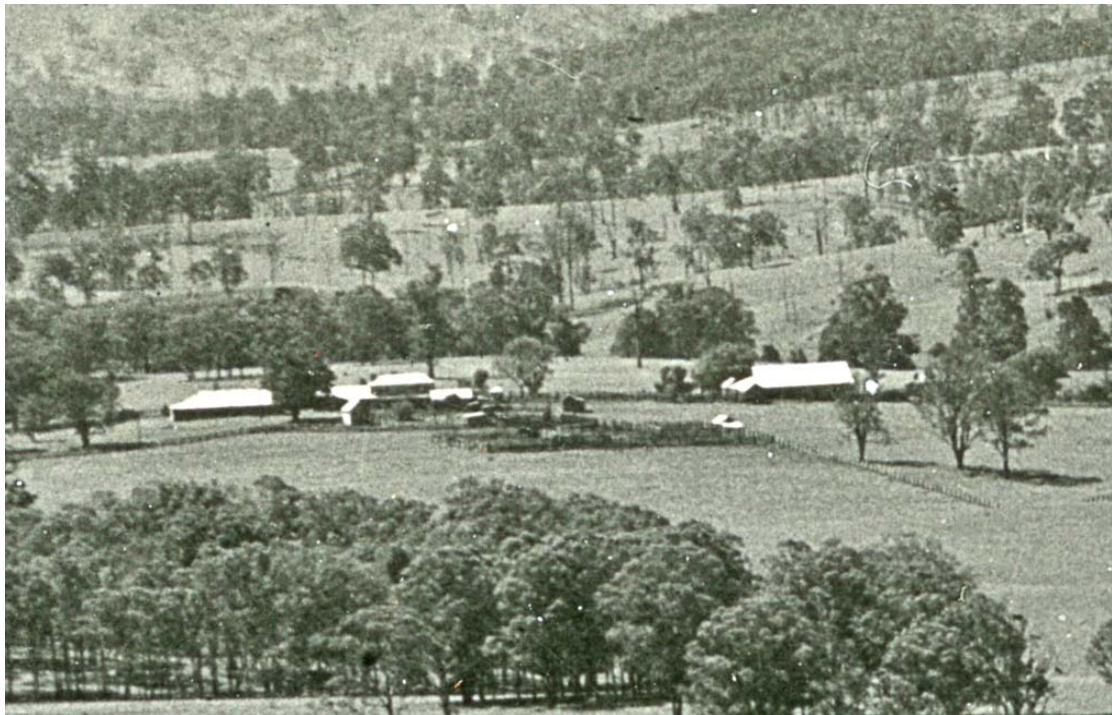
Here is the detail of Tillimby from the c1920s photo taken from Jordan's hill.

From the above detail it seems that a two-storey building, most likely the homestead, survived into the 1920s and appears to be a somewhat grand residence.

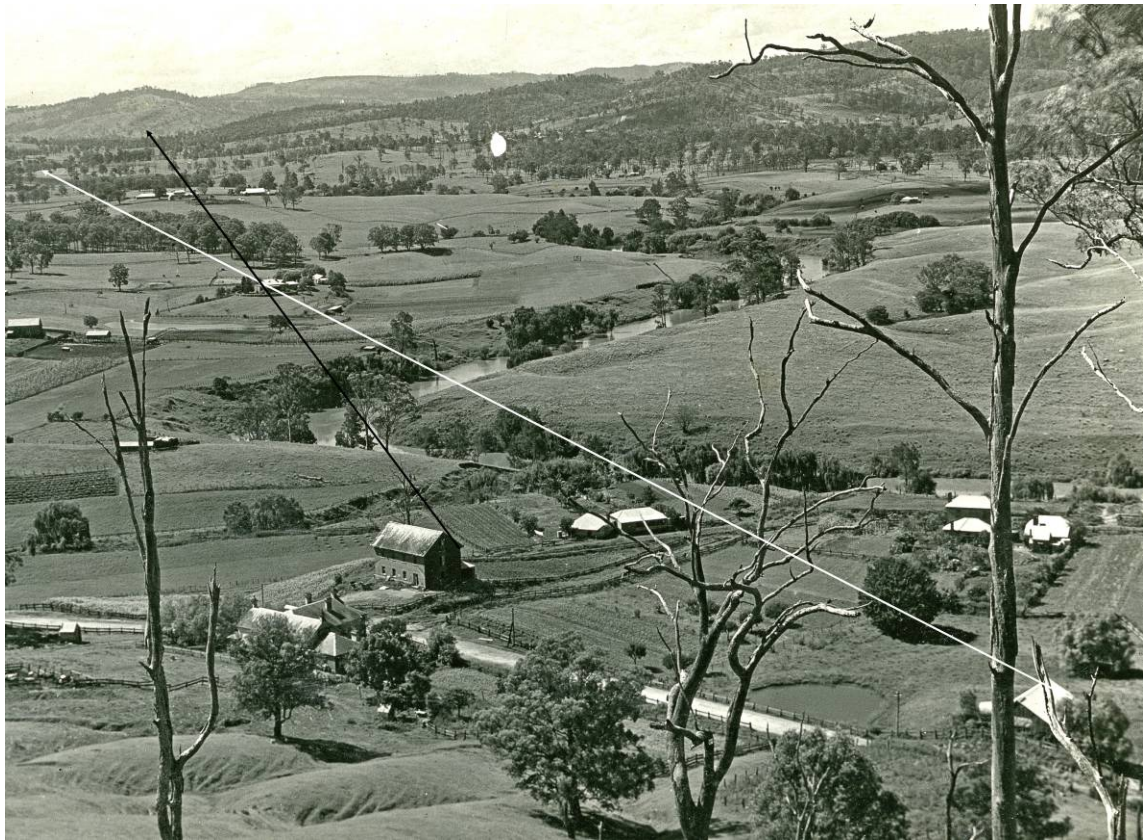
The next challenge is to locate the main residence in today's landscape using features from the Jordan's hill photo that are evident today. To achieve this a line was drawn from the south east corner of Corner's grain store, through the north west corner of Cintra (the black line in the photo on the next page). As a crosscheck another line was drawn from Jordan's house (before recent additions) through Cintra (the white line on the next page). The black line passes through the southern edge of Tillimby homestead. The white line passes about two and a half house lengths to the north west of Tillimby homestead. These same lines were then drawn on a modern satellite image to locate the homestead in the modern landscape.

Above and below: locating Tillimby homestead using reference points that survive today.

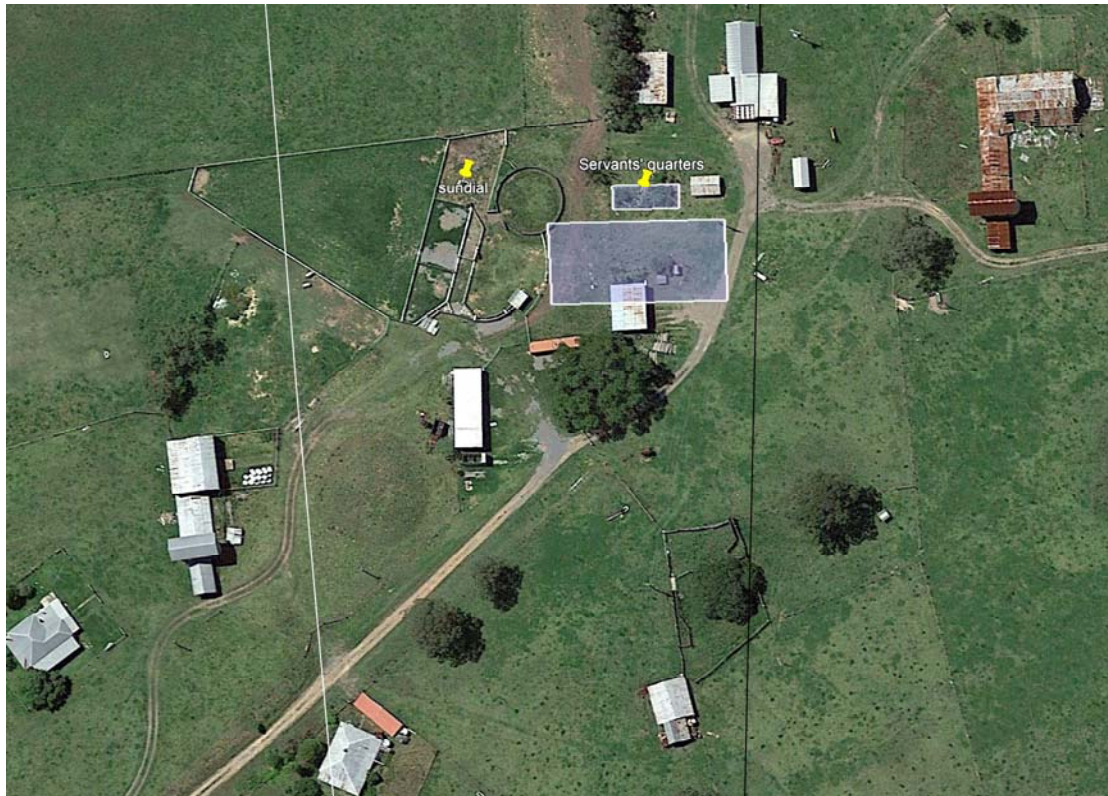
Above: the same lines passing through Tillimby, drawn on a 2016 satellite image.

Using the lines and natural features, Tillimby homestead has now been located with reasonable certainty (the dimensions of the house are approximate).

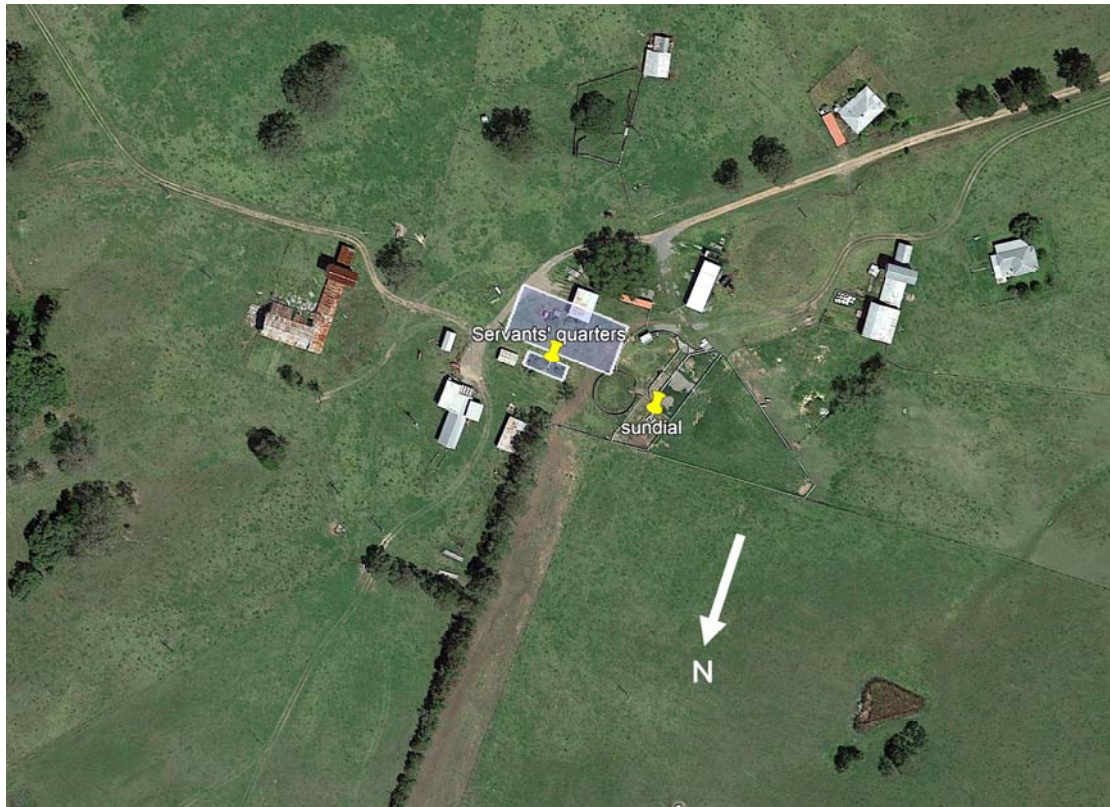
Now it is time to turn attention to an unidentified photo in the Paterson Historical Society collection that I have for some time suspected was Tillimby. It is stamped with the creator's name "Kerry & Co.". This photographic firm operated from 1890 to 1917. Before viewing the photo, we need to rotate the above satellite image, with homestead and servants' quarters superimposed, to match the view of the Kerry photo.

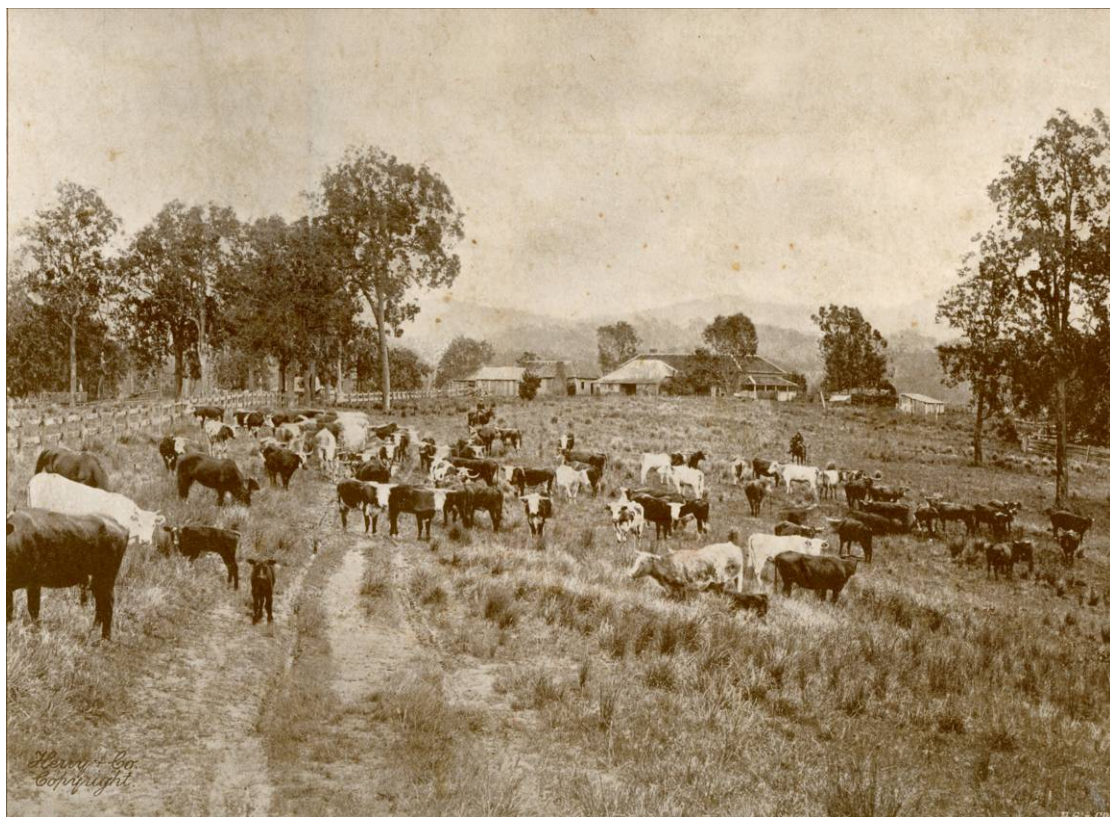
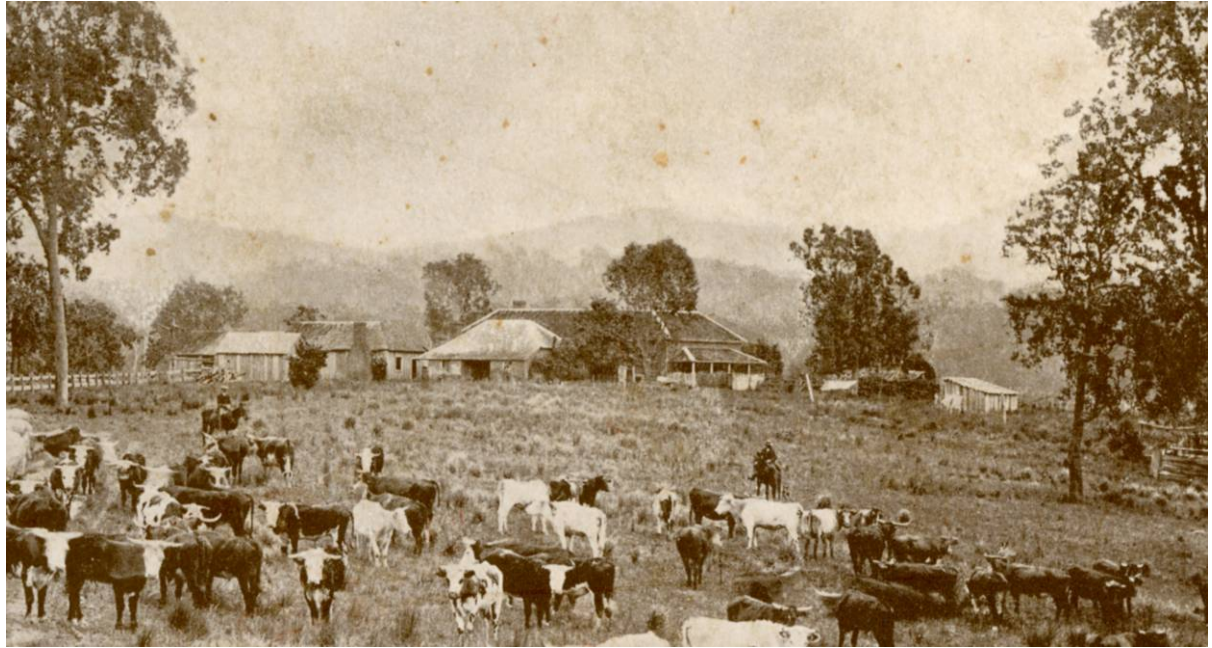
The location and dimensions of the servants' quarters and Tillimby homestead match those in the Kerry photo below. Also see more detail on the next page.

Taking all the evidence into account, I believe the large building in the centre of the Kerry photo above is Tillimby homestead, c1900. This means we have two views of Tillimby homestead – the view from Jordan's hill c1920s and the Kerry photo c1900.
